NAVWEPS REPORT 7630
NOTS TP 2635

EVALUATION OF PROPELLANT DEFECTS USING TRANSPARENT ROCKET MOTORS

Henry T. Sampson
Propulsion Development Department

U.S. NAVAL ORDNANCE TEST STATION

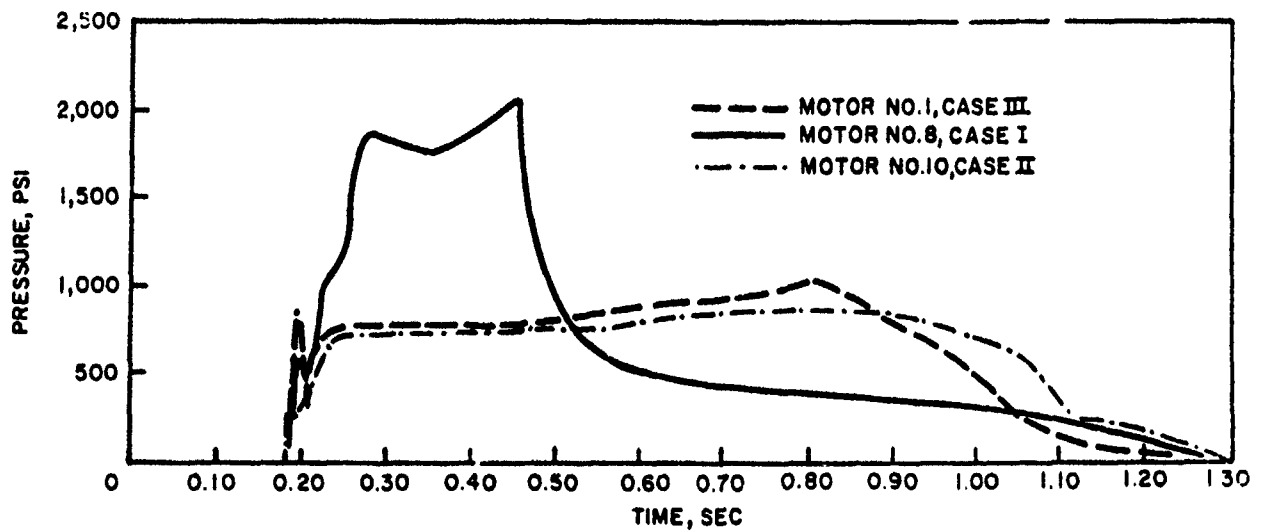
FIG. 8. Pressure-Time Curves, 2-Inch Motors No. 1, 8, and 10.

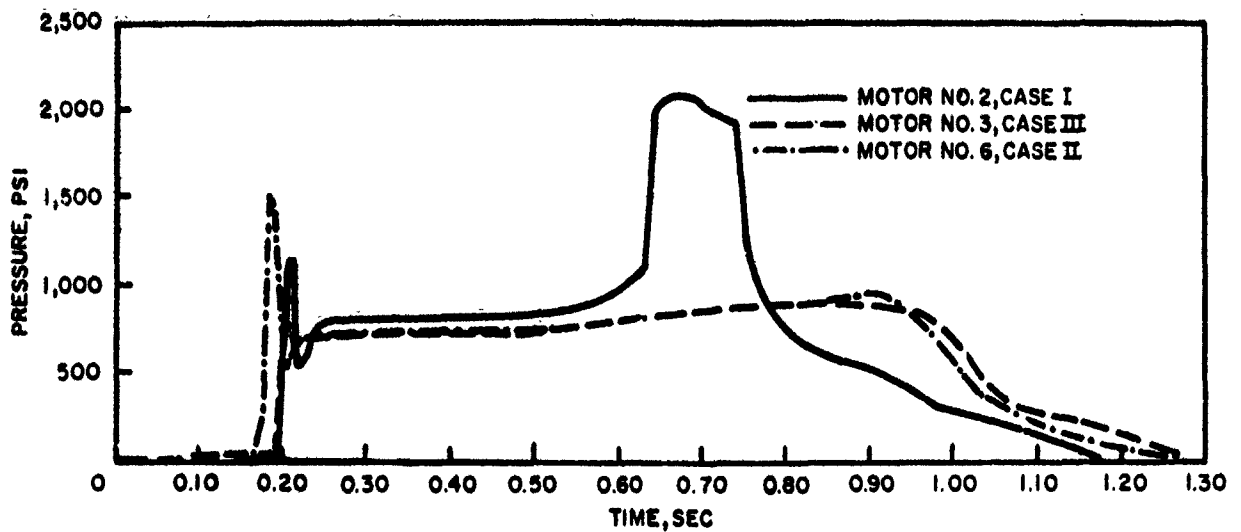
FIG. 9. Pressure-Time Curves, 2-Inch Motors No. 2, 3, and 6.

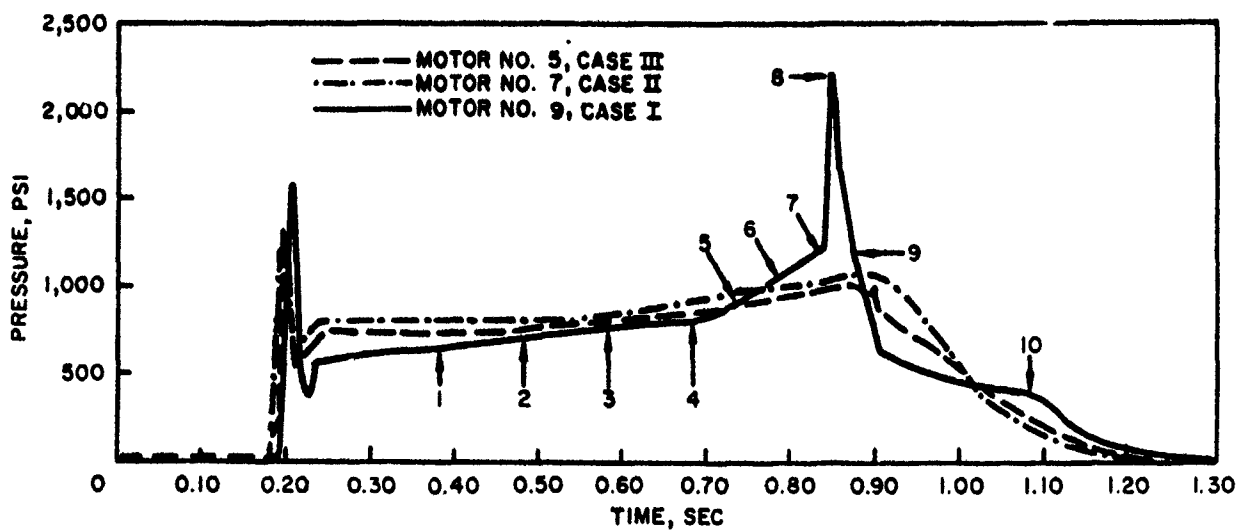
Results show that abnormal curves were obtained only from motors containing Case I defects. Motors No. 2, 8, and 9 show secondary pressure peaks occurring during various stages of motor operation. The peak for motor No. 2 occurred during the initial stages of burning, and the peak for motor No. 9 occurred during the latter stages. Film records were not obtained for motors 2 and 8 because of camera failures. The film record for motor 9, however, proved that the existence of the peak shown on the pressure record was due to side burning at the liner-propellant interface. This phenomenon was observed directly through the walls of the Lucite motor tube. Figure 11 is a picture sequence of

FIG. 10. Pressure-Time Curves, 2-Inch Motors No. 5, 7, and 9.

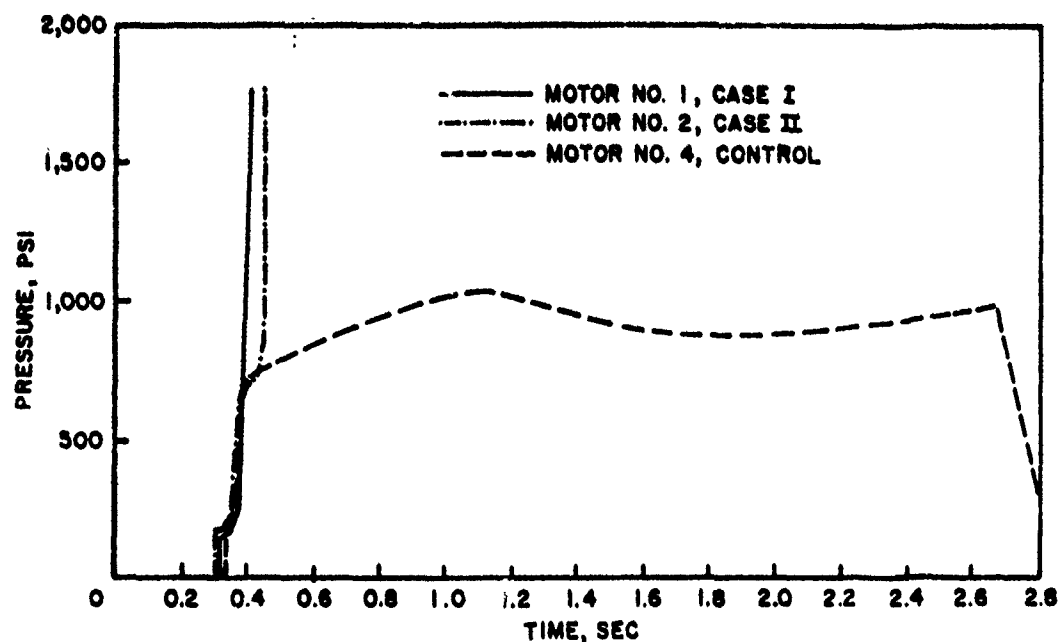
Because of the short burning time of the 2-inch motors, it was decided to repeat part of this experiment using 5-inch motors. Three 5-inch motors (No. 1, 2, and 4) were fired in an effort to confirm the results obtained with the 2-inch motors. One motor each of Cases I and II was fabricated, and one motor was used as a control. Measured separation was approximately 0.065 inch in all three motors. The pressure-time traces for these firings are shown in Fig. 12. Motor No. 4, the control round, burned normally with a total burning time of 2.483 seconds. Motor No. 1 (Case I) blew up after 0.032 second. The film record for this motor showed that side burning started at the head end of the motor 0.372 second after the igniter was energized, and ignition of propellant surface in the separation groove progressed at a rate of 795 in/sec. This abnormal result is consistent with the behavior of the Case I 2-inch motors. ~~The rate of propellant ignition,~~ however, is much higher, confirming the theory that the rate of ignition

FIG. 12. Pressure-Time Curves, 5-Inch Motors No. 1, 2, and 4.

propagation depends on the width of the separation. The probability that ignition will occur depends on the existence of gas flow channels in the ends of the propellant grain.

Five-inch motor No. 2 failed after 0.109 second of operation. This result was inconsistent with the behavior of the Case II 2-inch motors. The film record, however, for this motor showed that an unexpected flow channel developed at the head end of the motor approximately 0.440 second after the igniter was energized. Thus, at this time the motor became a Case I motor rather than a Case II. The calculated ignition propagation rate was 625 in/sec. At second glance, therefore, this result is consistent with that obtained with the 2-inch motors. Figure 12 shows the pressure-time curve for motor No. 2 to be similar to that for the control round during the initial phase of burning, indicating that motor No. 2 had attained steady-state operation before failure. It is thought that this motor would have burned normally, in spite of separation, had it not been for the development of the unexpected gas flow channel at the head end of the motor.

In both cases, the motor tube unaccountably failed well below the design pressure of 4,000 psi.

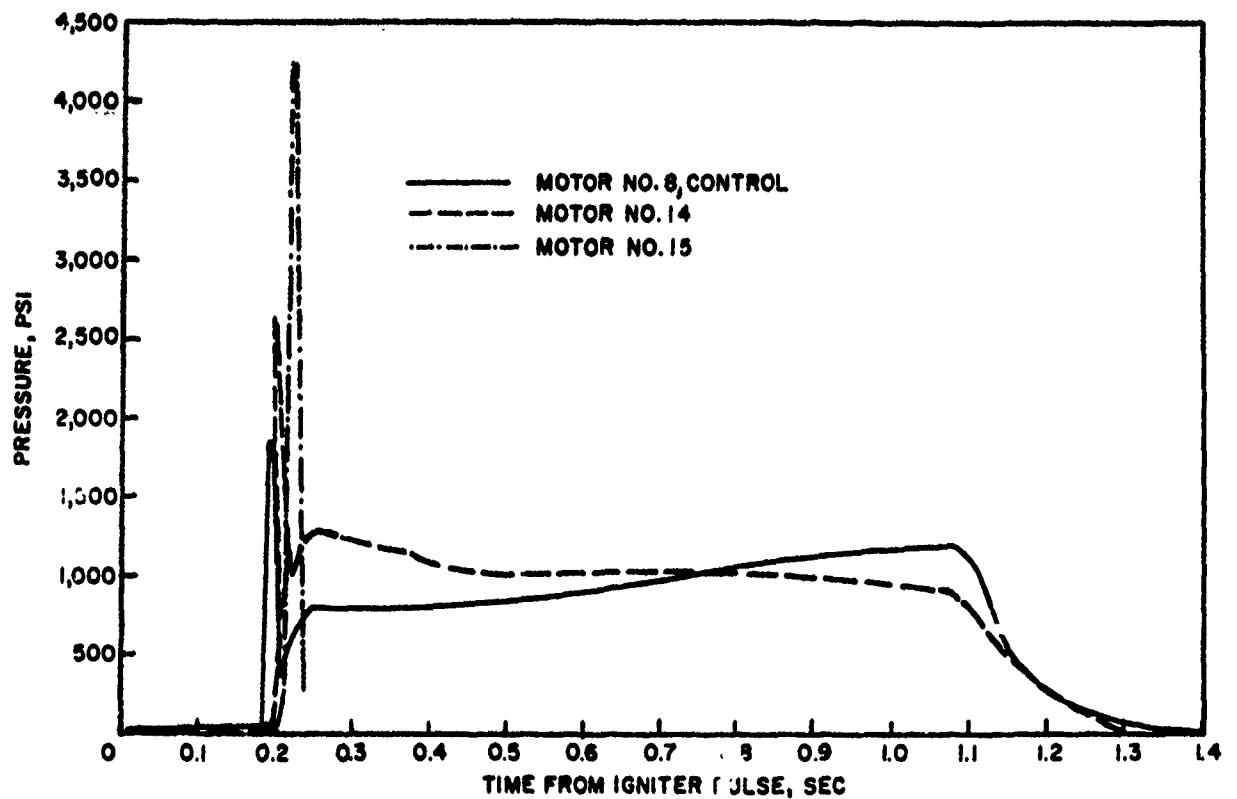
experiment and a summary of firing data. The corresponding pressure-time curves are shown in Fig. 13, 14, and 15. Motor No. 15 at 70°F and the control motor No. 9 at 120°F blew up. Photographic coverage was lost for these two motors, and, as a result, an explanation for their unexpected failure cannot be given. Extremely high initial-pressure peaks were obtained from all motors of this test series, including the control motors. Through a mistake in processing the propellant for these motors, coated ammonium perchlorate was used instead of the uncoated material. The higher pressure exponent of this material may have caused the high initial-pressure peaks.

These data indicate that the presence of a crack in the grain does not necessarily cause failure of the 2-inch motor. In fact, with the eight-point-star internal configuration, the presence of a crack changes the burning pattern of the grain from progressive to regressive. The progressivity ratio (ratio of burning surface at web burnout to initial burning surface area) changes from 1.28 without the crack to 0.73 with the crack. This effect is reflected in the pressure-time curves shown in Fig. 13. Because the propellant has a high temperature coefficient, the amount of progressivity or regressivity in the pressure-time curves is dependent upon the temperature of the grain before testing. This is seen by comparing the curves in Fig. 13 through 15. The pressure-time curves for the 120°F firings seem to be abnormal, having rather broad initial peaks. It cannot be determined, however, whether this is the result of temperature or of a crack in the grain, since the control motor fired at this temperature blew up.

FIG. 13. Pressure-Time Curves, 2-Inch Motors No. 8, 14, and 15.
